**AVALIAÇÃO DE ECOSISTEMAS AQUÁTICOS ATINGIDOS PELA LAMA  
DE REJEITO DO COLAPSO DA BARRAGEM DE FUNDÃO, MARIANA-MG:  
UMA PERSPECTIVA VIA SENSORIAMENTO REMOTO**

**AN ASSESSMENT OF AQUATIC ECOSYSTEMS AFFECTED BY THE  
FUNDAO TAILINGS DAM COLLAPSE, MARIANA-MG: A PERSPECTIVE BY  
REMOTE SENSING**

TESE APRESENTADA AO INSTITUTO DE  
GEOCIÊNCIAS DA UNIVERSIDADE ESTADUAL  
DE CAMPINAS PARA OBTENÇÃO DO TÍTULO DE  
DOUTORA EM CIÊNCIAS NA ÁREA DE  
GEOLOGIA E RECURSOS NATURAIS

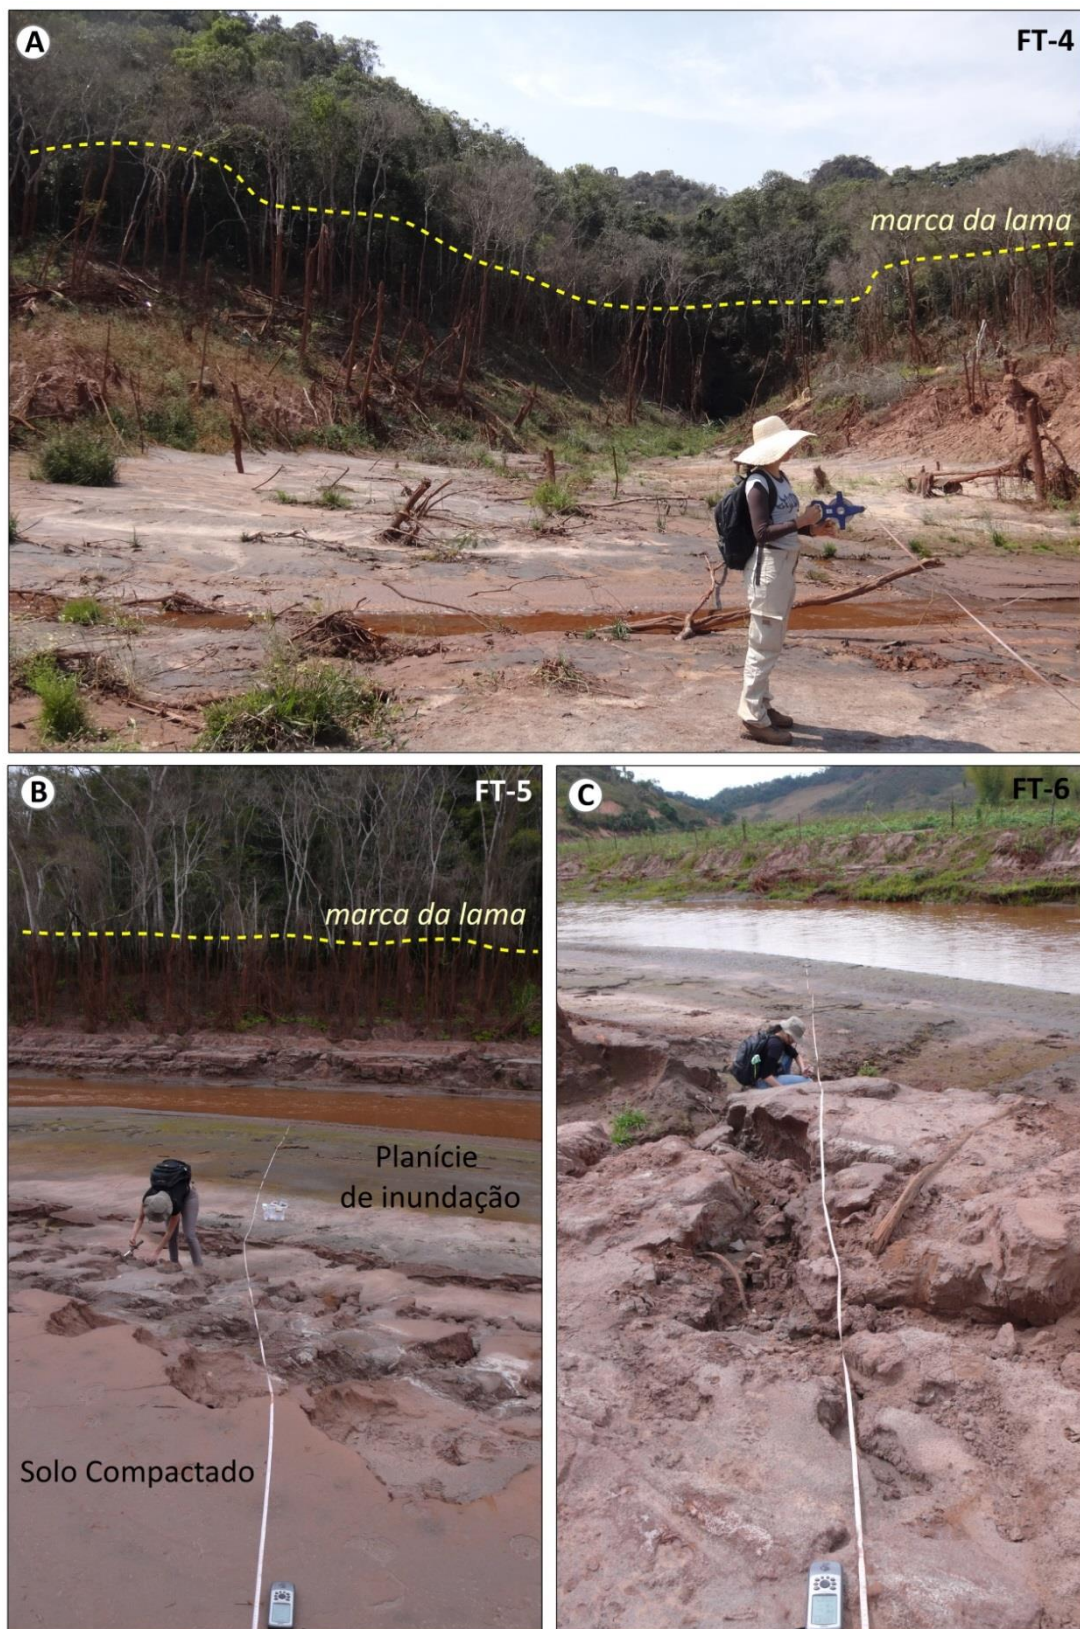
**Fig.9.** Áreas atingidas pela lama mostrando os danos ao solo e à vegetação. (A) Região de Bento Rodrigues, onde a avalanche arrancou grande volume de árvores. (B e C) Margens do rio Gualaxo do Norte, na região de Paracatu de Baixo. Ressalta-se o solo compactado com ausência de vegetação e matéria orgânica, além de locais caracterizados por ravinas e sulcos erosivos. Fotos FT-4 a FT-6 obtidas no dia 14 de setembro de 2016 (Fonte: Acervo pessoal).

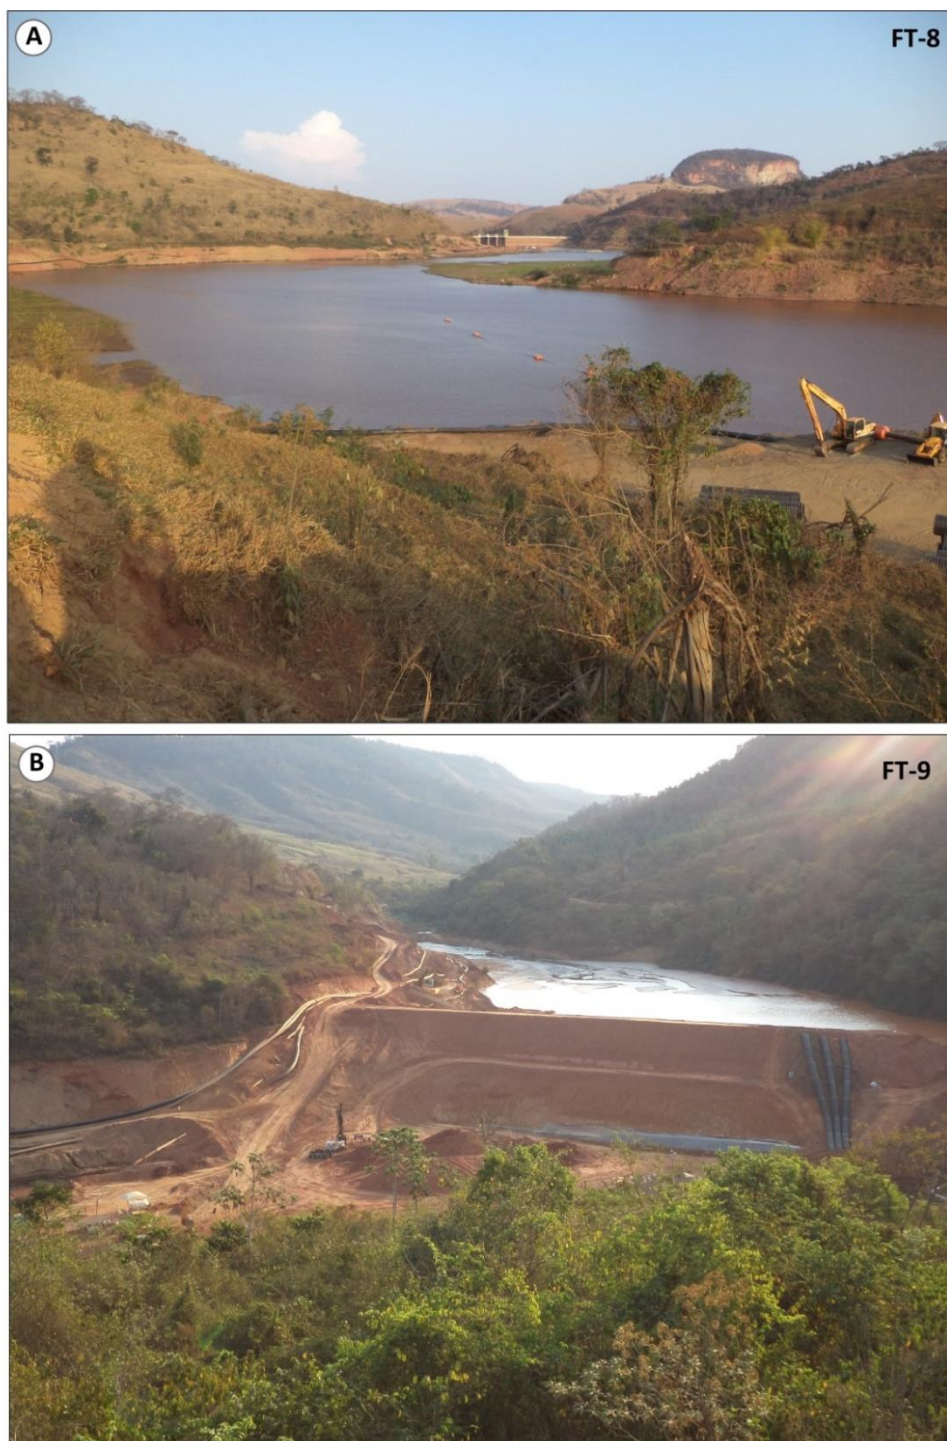
**Fig.11.** (A) Barragem da UHRN, mostrando a área considerada prioritária para retirada de rejeito. (B) Vista para um dos diques construídos na Fazenda Floresta, que compreende parte do processo de remoção do rejeito do reservatório. Fotos FT-8 e FT-9 obtidas em 18 de setembro de 2016 (Fonte: Acervo pessoal).

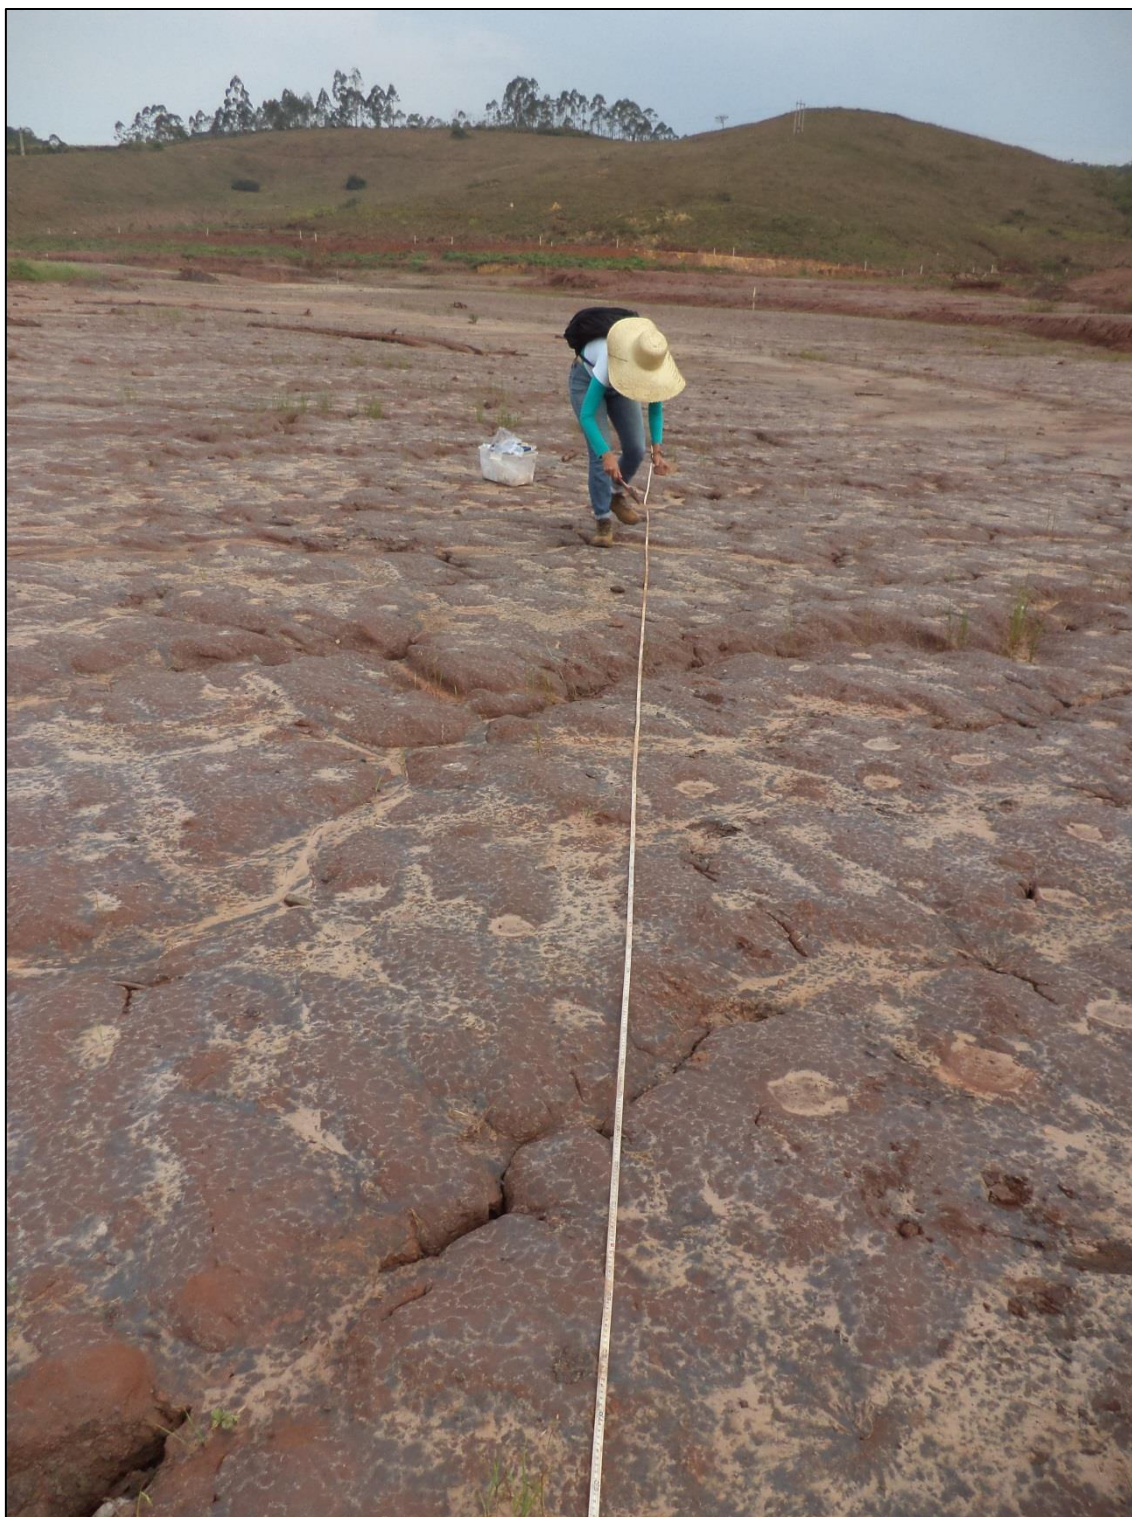
**Fig. 5.** Foto obtida em 19 de setembro de 2016. Solo encoberto pelo rejeito, bastante compactado e exibindo processos erosivos iniciais. Fonte: Acervo pessoal.

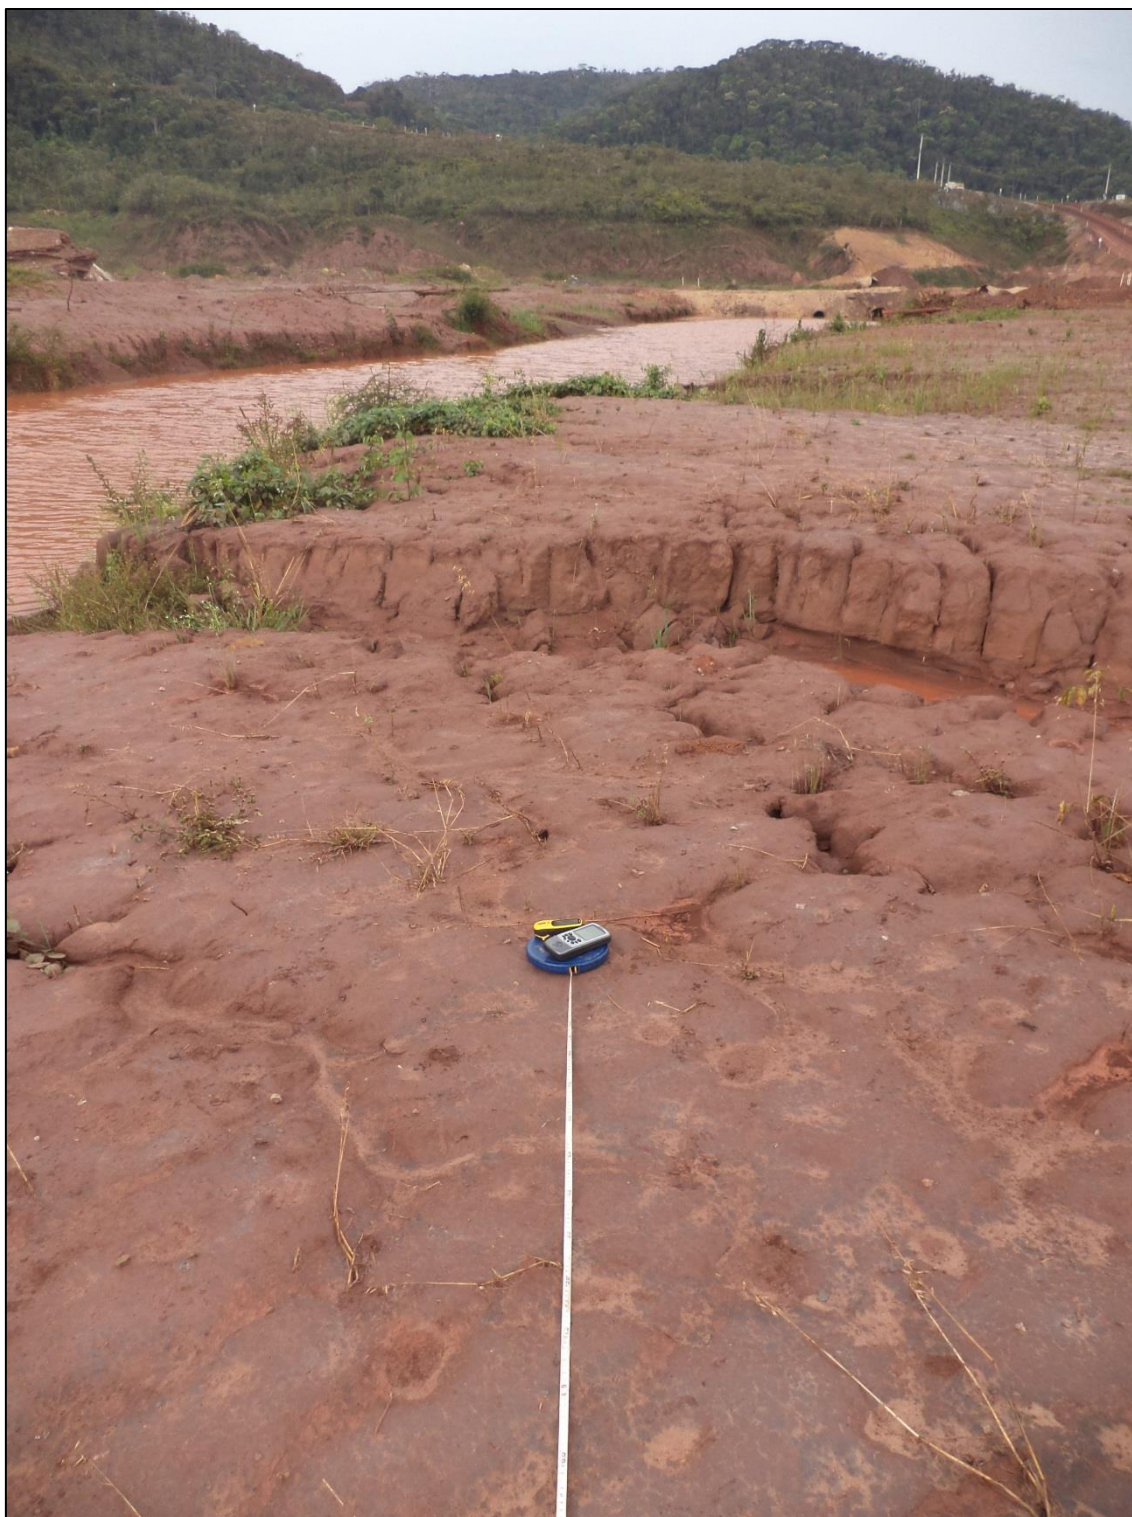
**Fig. 6.** Foto obtida em 19 de setembro de 2016. Planície de inundação do rio Gualaxo do Norte encoberta pelo rejeito, totalmente sem vegetação. Destaca-se na foto a elevada turbidez da água. Fonte: Acervo pessoal.

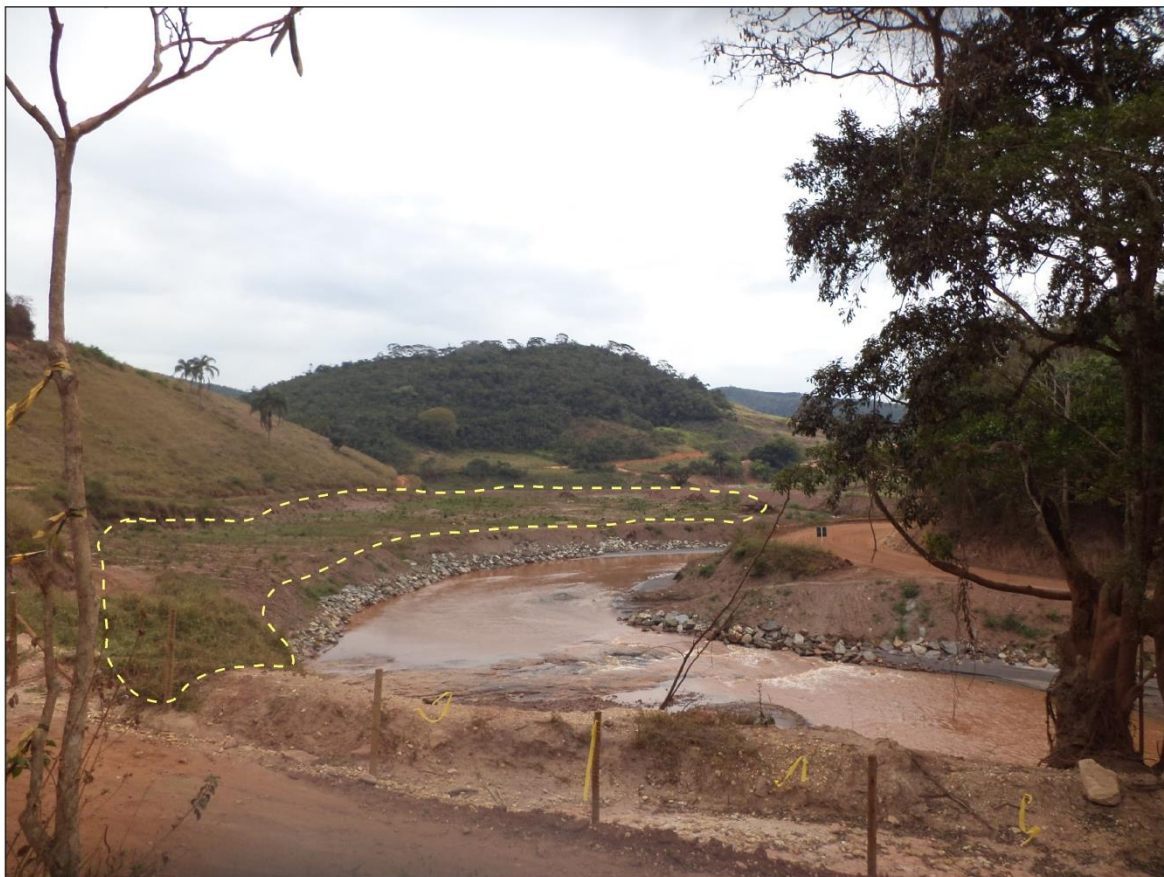
**Fig. 6.** Foto obtida em 16 de setembro de 2016. Planície de inundação do rio Gualaxo do Norte. Nesse local foi plantado uma mistura de leguminosas as margens do rio para a reparação do solo, destacado com a linha tracejada. Fonte: Acervo pessoal.

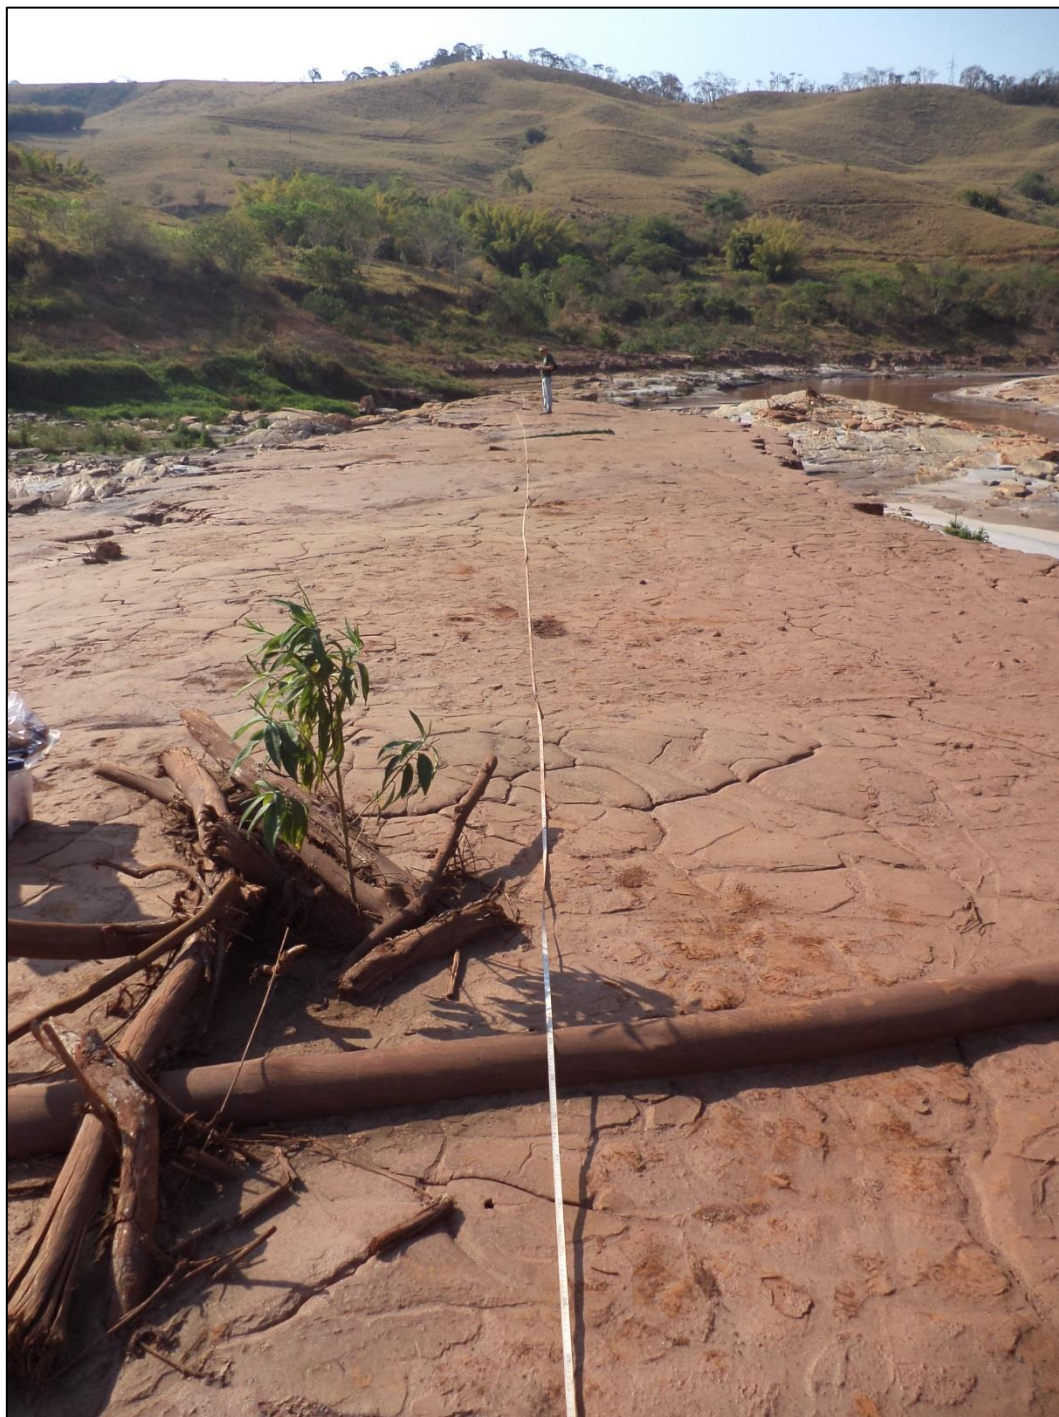
**Fig. 7.** Foto obtida em 18 de setembro de 2016. Planície de inundação do rio Doce, a montante da UHRN. Solo totalmente compactado e sem matéria orgânica e vegetação. Fonte: Acervo pessoal.

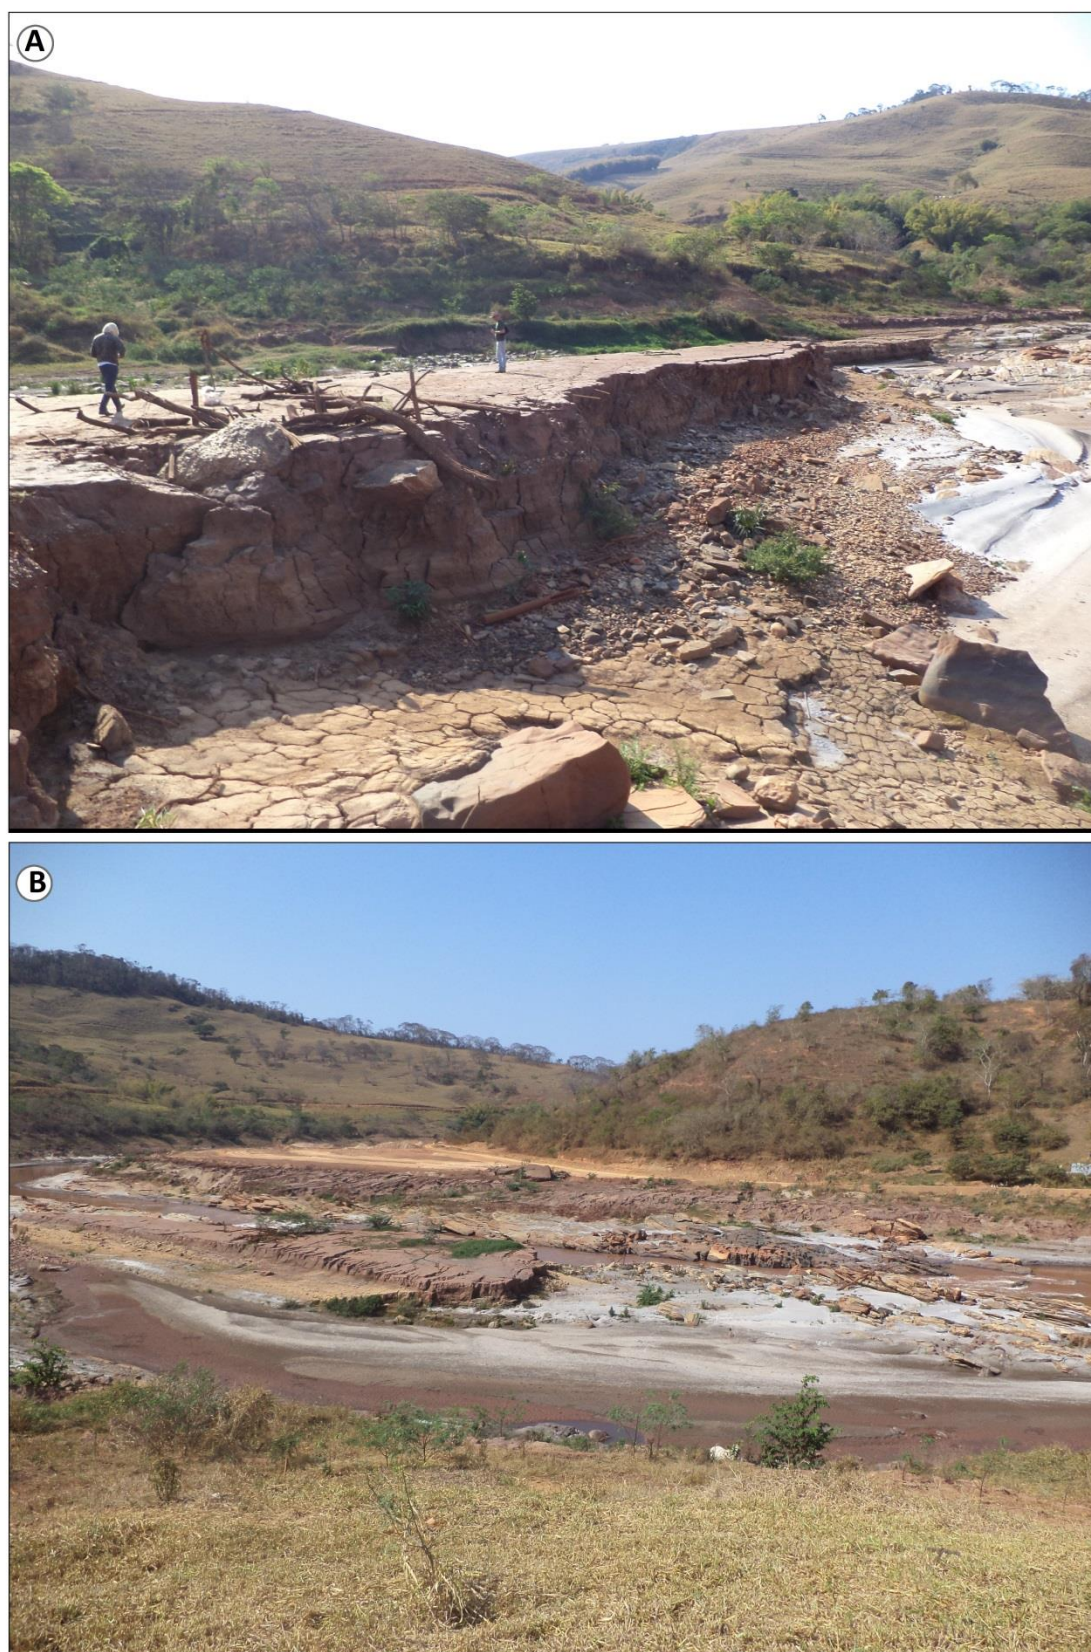
**Fig. 8.** Foto obtida em 18 de setembro de 2016. Planície de inundação do rio Doce, a montante da UHRN. (A) Solo totalmente compactado e com rachaduras. (B) Trecho do rio Doce, com baixo nível d'água e o intenso assoreamento pelo rejeito depositado as margens do rio. Fonte: Acervo pessoal.
