# Precision Geometric Levelling for the Control of Vertical Displacements in the Recovery and Reinforcement of Concrete Beam, a Case Study

## Nivelación Geométrica de Precisión para el Control de Desplazamientos Verticales en la Recuperación y Refuerzo de una Viga de Concreto, Estudio de Caso

M. Françoso \*, I. Pizarro <sup>1\* \*\*</sup>, L. de Almeida \*, M. da Silva \*

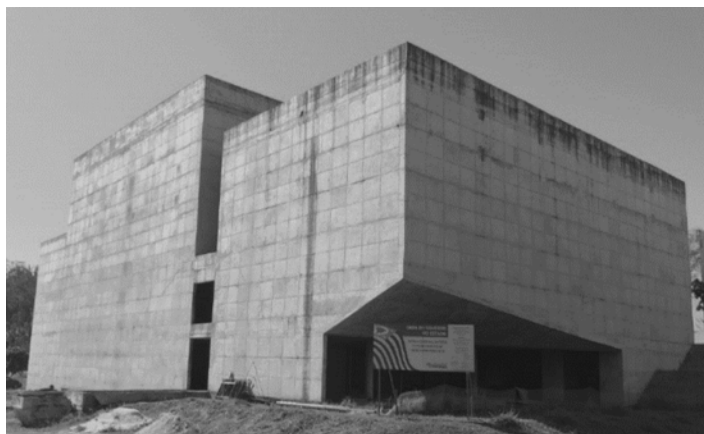
Figure 1. Unicamp Arts Institute Theatre

Unicamp Arts Institute Theatre ("Teatro-Laboratório do Instituto de Artes") is a reinforced concrete work, in a construction phase, comprising of two modules: the theatre (main module) and the entrance building which offers access to the theatre, made up by three floors, basement, mezzanine and general top floor (denominated as attached module), inside a total area of 5.668,73 m<sup>2</sup> (Figure 1), located at the University of Campinas and based on the University City "Zeferino Vaz" in Campinas (SP).

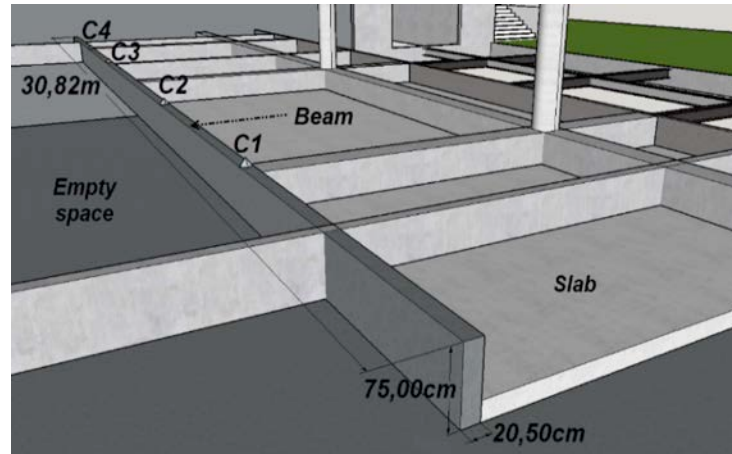
Figure 2. First floor beam undergoing the recovery process

As related to case study, a beam which is part of the first slab, located at the attached module of the building was selected. It is a reinforced concrete beam, supported in its ends onto rectangular cross section column walls (average height and width of 75,00 cm x 20,50 cm) and 30,82 m longitudinal length (Figure 2).

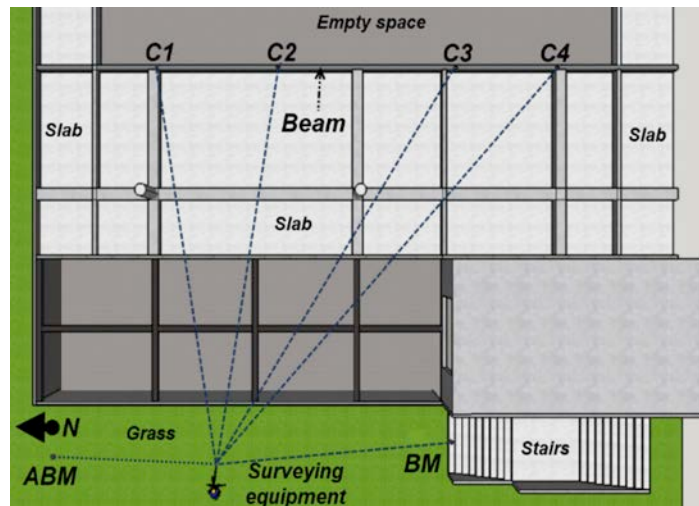
**Figure 3.** Under monitoring beam site plan with the control points location (C1, C2, C3, C4), the Benchmark (BM), the auxiliary Benchmark (ABM) and surveying equipment installation location

Both control points and reference level were marked with flat head bolts, fixed in the concrete to ensure observations on the same places always. The monitored points were denominated from left to right, as: C1, C2, C3 and C4 with average proximity to the 20,00 cm transducers. refer to details on (Figure 3) (Figure 4) (Figure 5.).

During the three stages, the level was installed outside the building with accessible line-of-sight for benchmark and the four control points as from a same installation point (Figure 3) (Figure 4). A series of readings were carried out in the first stage to allow knowing the beam's initial deformation state. On the second stage, six reading series were carried out, aiming at following up the gradual application of loads. In this process, loads were applied in ten-minute intervals, being the required time to evaluate through a visual inspection, the state of the structure and conduct the survey of the series of readings. For the third stage, four series of

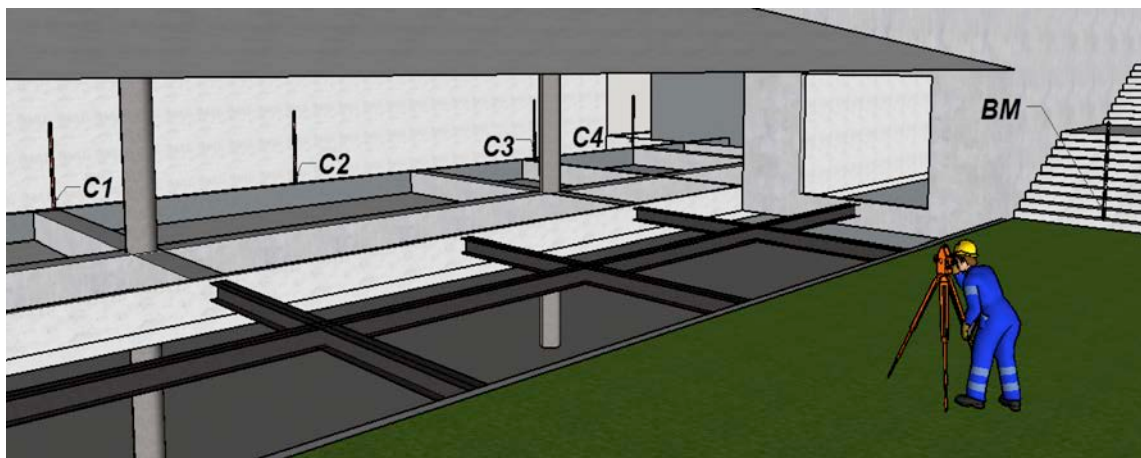
**Figure 4.** The surveying equipment installation side view as related to Benchmark location (BM) and control points (C1, C2, C3 and C4)

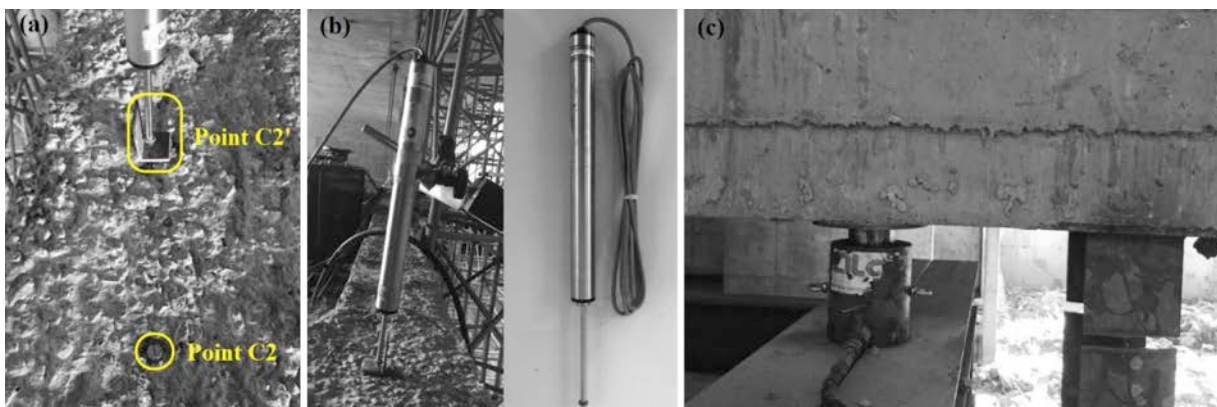
**Figure 5.** (a) Control points location (C2 and C2'); (b) Displacement transducers and (c) Jack used to apply the loads and temporary cut columns

Instrumentation monitoring was carried out by means of a computer with data acquisition system, "System 5000", model "5100b Scanner" from "Micro-Measurements" brand and four displacement transducers also from "Micro-Measurements", gauged with a precision of a thousandth of a millimetre (Figure 5.). Instrumentation technique was used exclusively in the second monitoring stage, with data acquisition at each second.

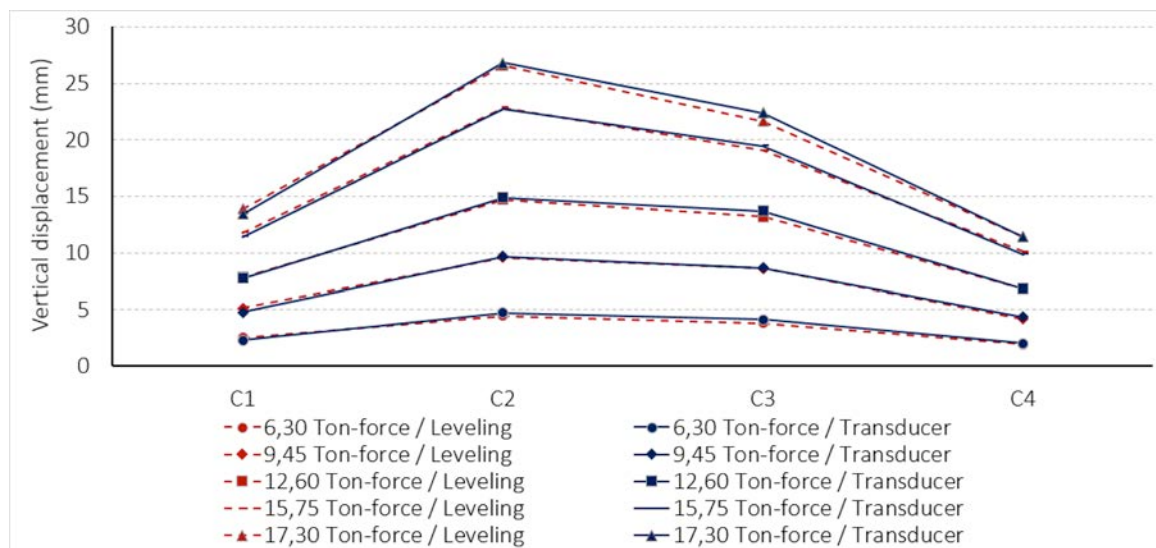
**Figure 6.** Graphic of the results' comparison obtained with levelling and displacement transducers

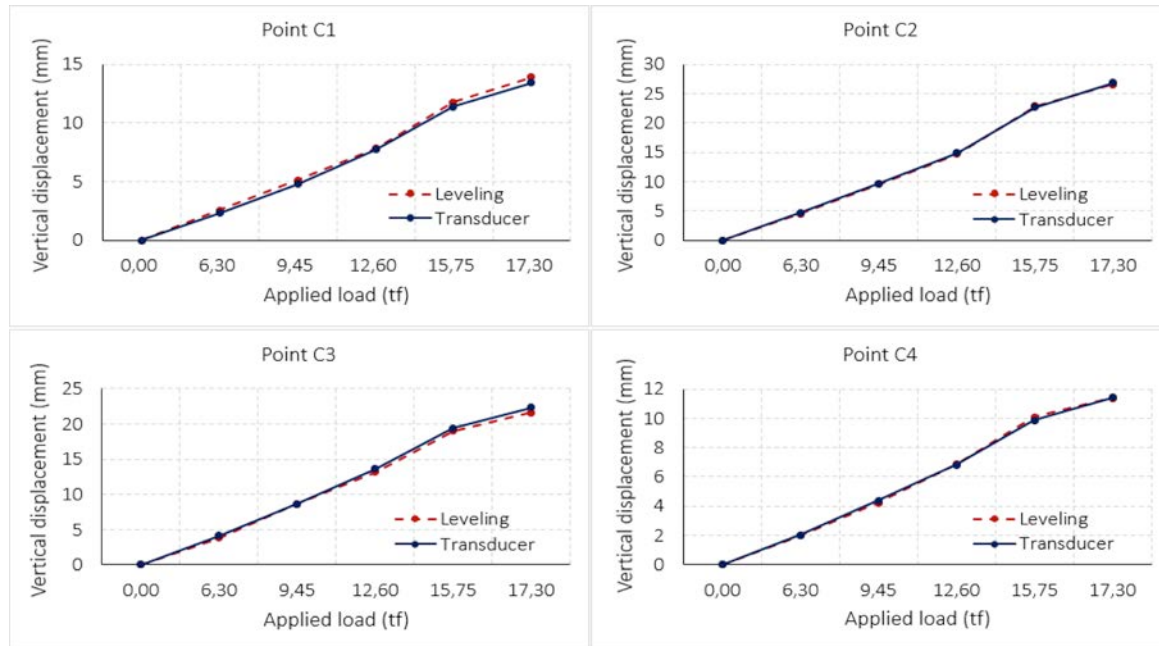
**Figure 7.** Vertical displacement given the applied load for each control point, using of the two monitoring techniques

(Figure 7) presents each control point behaviour in an isolated way, with the vertical displacements being experienced given the applied load. The graphics offer a purpose of which is to facilitate the results' comparison over each point, besides enabling the correlation analysis between the involved variables (Load and Displacement).

It is evident that irrespective of the displacements' magnitudes or the technique employed, the four graphics present bends with similar trends and forms, suggesting a strong linear correlation between the variables. The correlation coefficient ( $R^2$ ), which explains the proportion of variation between data, in all cases, was higher than 99%.

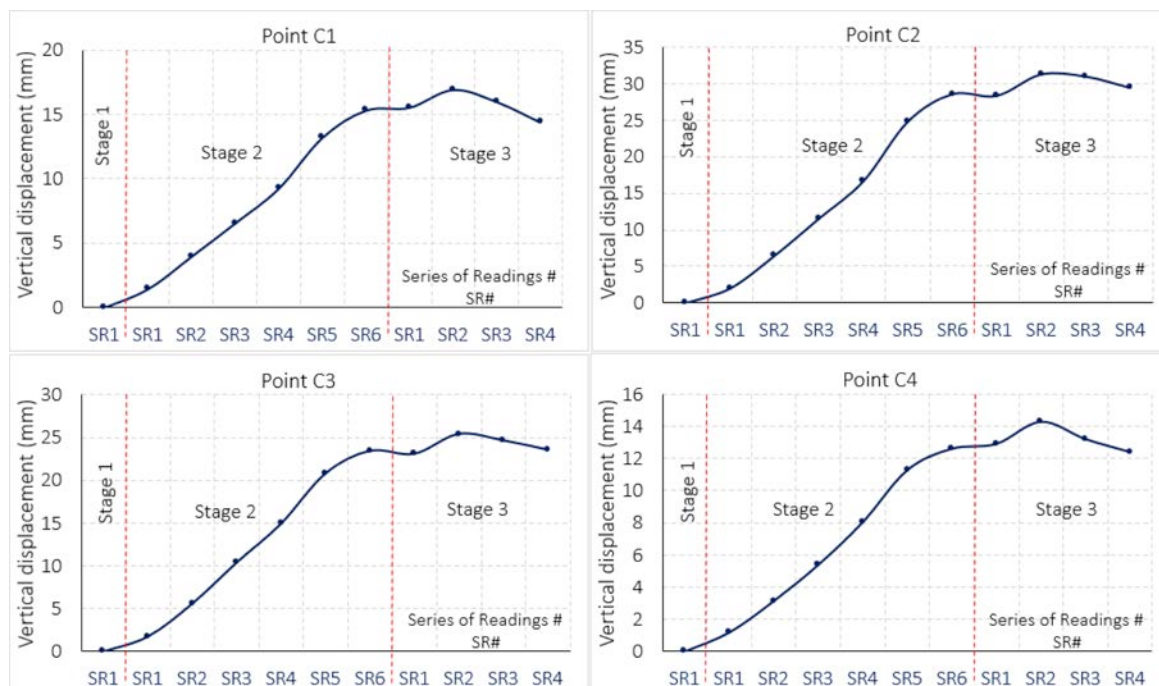
**Figure 8.** Displacement behaviour bends in each monitored point during the three Stages, using precision geometric levelling

As previously mentioned, monitoring with levelling was carried out in the three defined stages in the study, aiming at following the behaviour of the beam, prior, during and after rehabilitation process and reinforcement. Such

behaviour, in terms of vertical displacements given the stages and series of readings, is presented in (Figure 8). The trend of the four bends in the second stage was clarified in the previous paragraph; however, the displacement variations in stage 3 match the following situations:

- 1) on the transition between stages 2 and 3, after 24 hours of the recovery process with structural jacking, the structure underwent minor increases in the displacements of the extreme points ( $C1 = 0,225$  mm and  $C4 = 0,300$  mm) and a decrease in internal points ( $C2 = 0,225$  mm and  $C3 = 0,350$  mm);
- 2) 3 days after, the last applied load had to be adjusted, aiming at implementing the four columns, being observed then, a significant increase of the displacements, mainly in the internal control points ( $C1 = 1,387$  mm,  $C2 = 2,925$  mm,  $C3 = 2,325$  mm,  $C4 = 1,375$  mm) and
- 3) lastly, when the jacks were removed, the beam rested on the reinforcement columns. On this stage, as expected, the displacements decreased up until similar values to those determined in the last load applied (17,30 tf) in stage 2.
